**James Harrison Elementary
School (JHES)**

**UPPER PATUXENT RIVER WATERSHED RESTORATION ACTION STRATEGY (WRAS)
FORM 1 -- Catchment Information**

UPPER PATUXENT RIVER WATERSHED RESTORATION ACTION STRATEGY (WRAS) FORM 2 -- Site Information

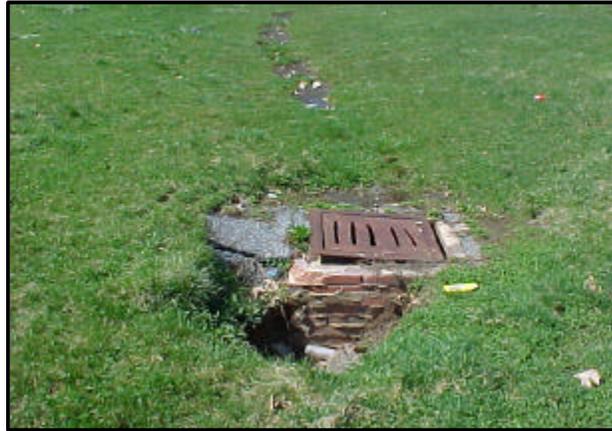
- No. 491 Description: looking north at east (front) side of school
- No. 492 Description: looking northwest at south side of building
- No. 493 Description: looking north at west side of school
- No. 494 Description: looking west at north side of building
- No. 495 Description: looking south at east side of building
- No. 496 Description: looking east at north side of building
- No. 497 Description: looking south at west side of building
- No. 498 Description: failing inlet
- No. _____ Description: _____
- No. _____ Description: _____
